# The Risks of Excess Water on Tailings Facilities and Its Application to Dam-break Studies

H Rourke & D Luppnow

This paper was first presented at Tailings and Mine Waste Management for the 21st Century, Sydney, NSW, 27–28 July 2015

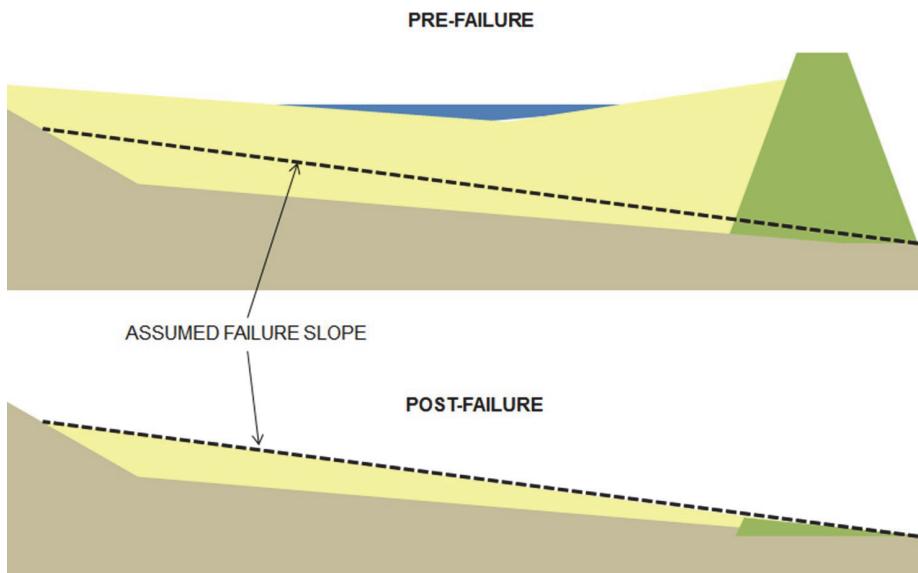
**FIG 1 – Estimating release volume based on an assumed post-failure slope.**

Unlike water dams, where a breach spanning the full height of the embankment will result in the entire storage volume being released, it is widely accepted that TSFs are more likely to retain some solids due to the viscous nature of the tailings. Applying this principle, some dam-break studies have assumed a post-failure tailings surface sloping at an angle of about 3 to 10° from the downstream toe, as illustrated in Figure 1.

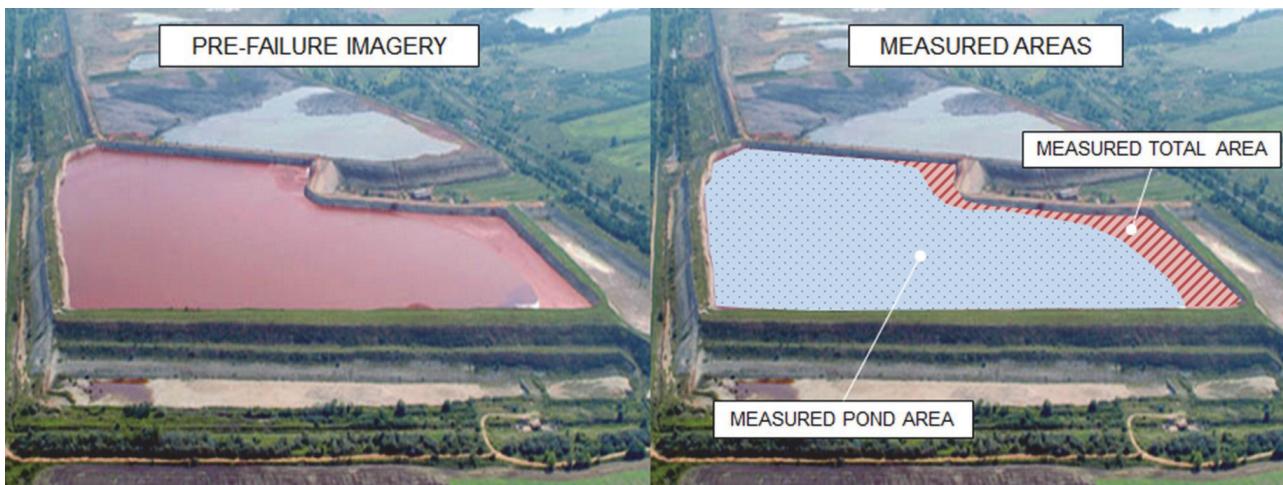
**FIG 2 – Prefailure imagery and area measurements of the Kolontár tailings dam (imagery taken in June 2010 by Hungarian aerial photography company Interspect).**

The prefailure pool area was estimated using an aerial image taken in June 2010; a few months before failure (see Figure 2).

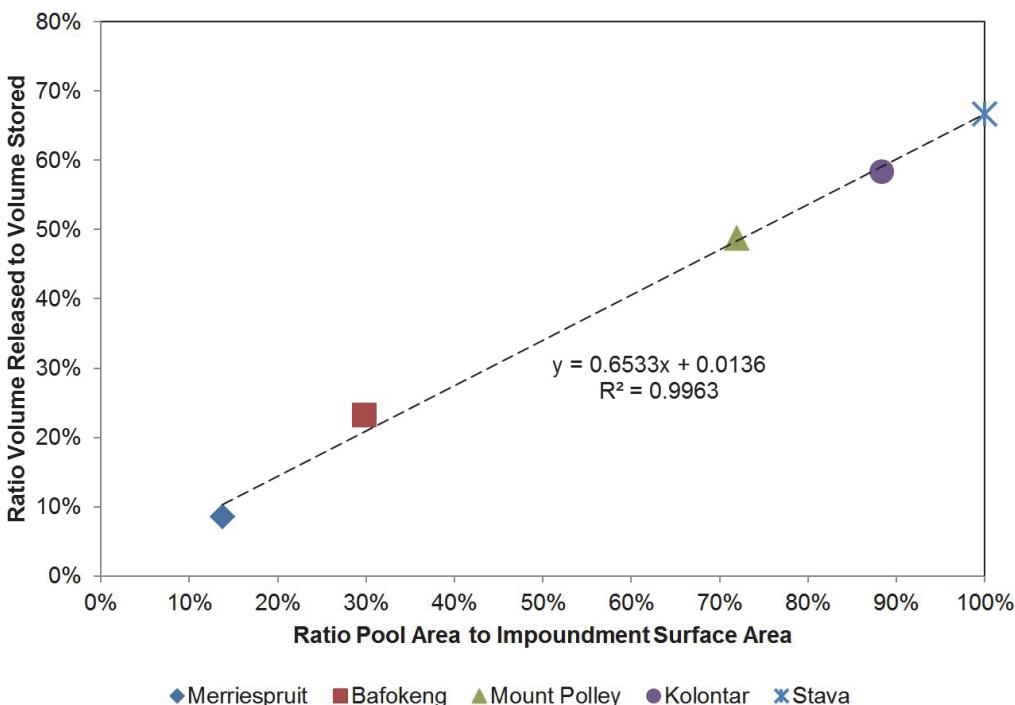
**FIG 3 – Graph of the volume ratio (volume released to volume stored) versus pool ratio (pool area to impoundment surface area) with regression.**

A summary of the data collected for these five case studies is presented in Table 1. These data were then plotted in Figure 3, which shows the volume ratio (release volume to storage volume) versus the pond ratio (pond area to TSF area) and provides the following regression equation:

This equation provides a surprisingly good correlation for the five case studies analysed and serves as a starting point for incorporating the influence of water in estimating potential failure volumes. It is acknowledged that this is a simplistic relationship that has been developed from limited data. It is expected that a reasonable correlation will still be achieved when additional data are incorporated, but that the  $R^2$  value will likely decrease.
